### 1.0 Issue

AEC2.1 extension boards (AEC2.1 4 Wiegand Reader Board and AEC2.1 8 Input-Output Board) shipped having the following serial numbers:

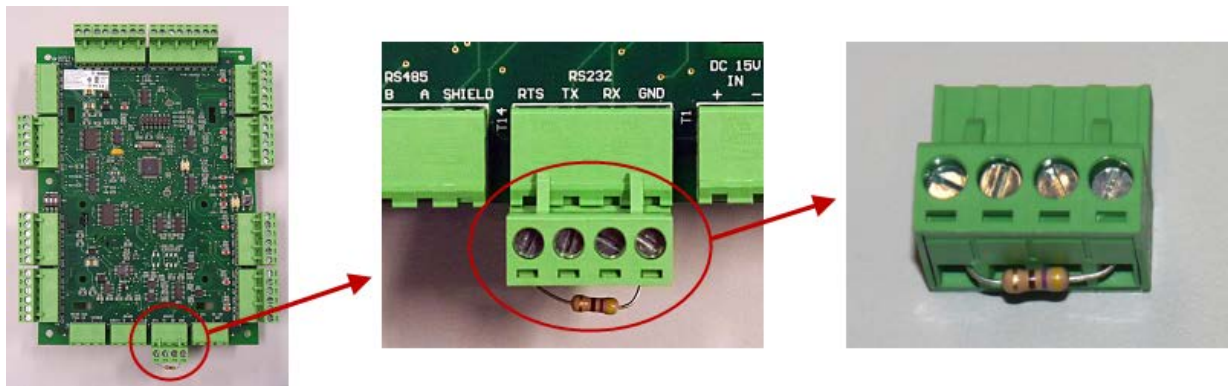
AEC 2.1 systems may exhibit the following symptoms when two or more extension boards are connected:

- AEC panel produces a continuous beeping sound that indicates a loss of communication between the CPU and extension boards.
- The AEC system is unable to detect some extension boards.

- Customers will fix the 470 ohm resistors to the termination point T14 on the extension boards of AEC2.1 4 Wiegand Reader Board and/or AEC2.1 8 Input-Output Board. The resistors are terminated at the end points (RTS and GND) of the four-way connector.
- The included reader board in the APC-AEC21-UPS1 kit will not require a 470 ohm resistor. All other extension boards (2-16) connecting to the supplied reader board in the UPS1 kit will require this resistor if experiencing the symptoms outlined in section 1.0 Issue and validated by technical support.

- Perform a system reboot to restore AEC 2.1 communication between the CPU and extension boards.
