# TECHNICAL INFORMATION

## ICP-CC488P, CC408P, CC404P

### PCB Modifications

December 19, 2008

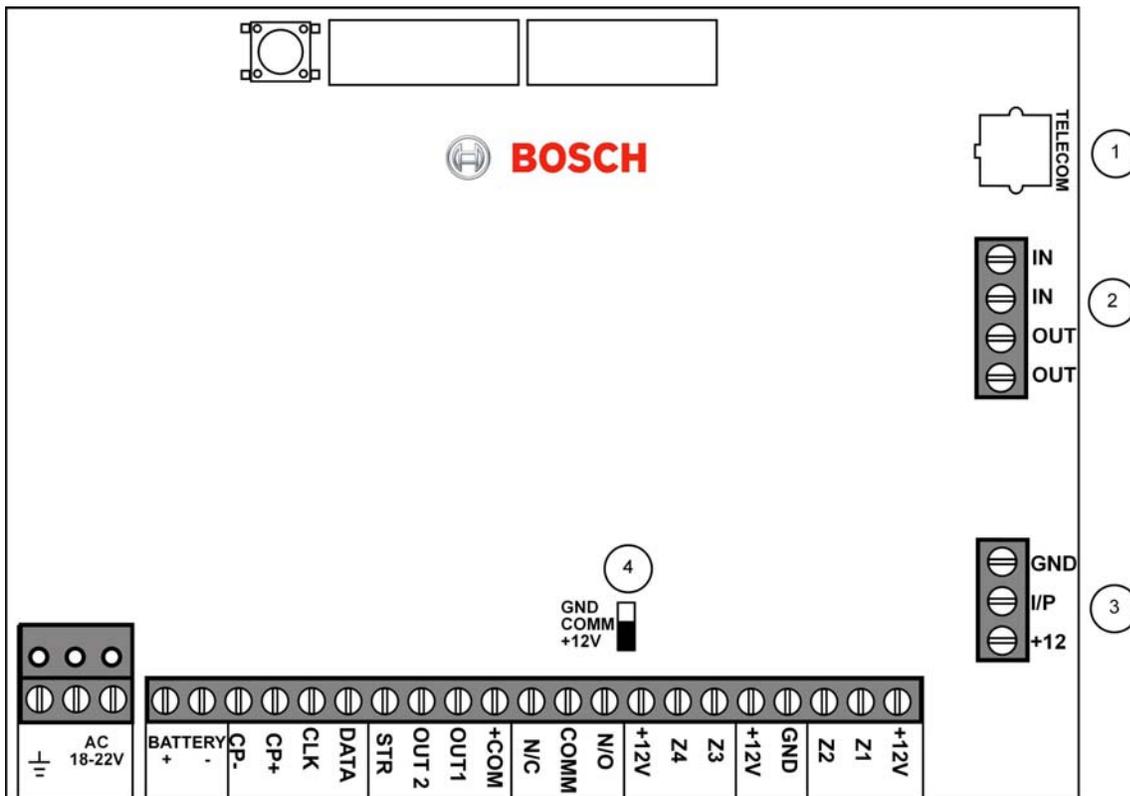
This version of the Solution ICP-CC488P, ICP-CC408P, or ICP-CC404P Control Panel Printed Circuit Board (PCB) is modified when compared to earlier versions. Make sure you pay attention to the modifications when creating your PCB connections. The PCB modifications are described below:

- TELECOM connector (Item 1): This connector is in a new location on the PCB.
- TELECOM terminal block (Item 2): This terminal block is in a new location on the PCB.
- Receiver Interface terminal block (Item 3): This terminal block is in a new location on the PCB, and the terminals are reversed when compared to earlier PCBs. This terminal block is available only on the ICP-CC488P Control Panel PCBs.
- Relay Contact connector (Item 4): This connector is in a new location on the PCB, and the terminals are reversed when compared to earlier PCBs.
