RADION receiver SD

B810

These Release Notes are for the RADION receiver SD with firmware version 3.01.

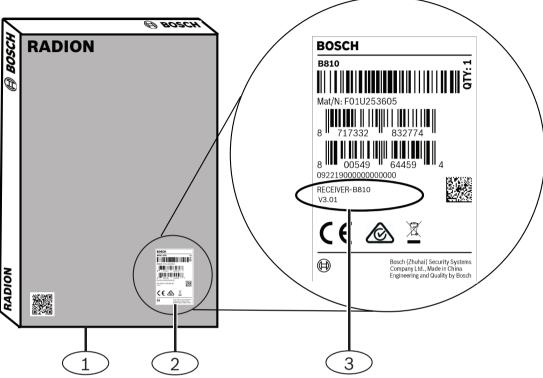
Figure 4.1: B810 box label and firmware version

Callout — Description

- 1 Receiver box
- 2 Receiver box label
- 3 Receiver firmware version

The receiver and the receiver's box show the original firmware version installed during manufacturing. You can use the RPS diagnostics feature to determine the B810 firmware version at any time. The B810 must be connected to a compatible control panel. Refer to the figures to locate and determine your receiver's original firmware version.

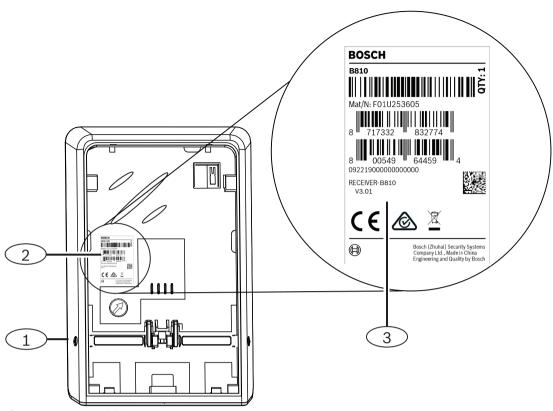
Figure 4.2: Receiver lable

Callout — Description

- 1 Receiver
- 2 Receiver label
- 3 Receiver firmware version
